Repairing an HP logic probe

I published a repair article in the May 2021 publication of Practical Wireless Magazine.

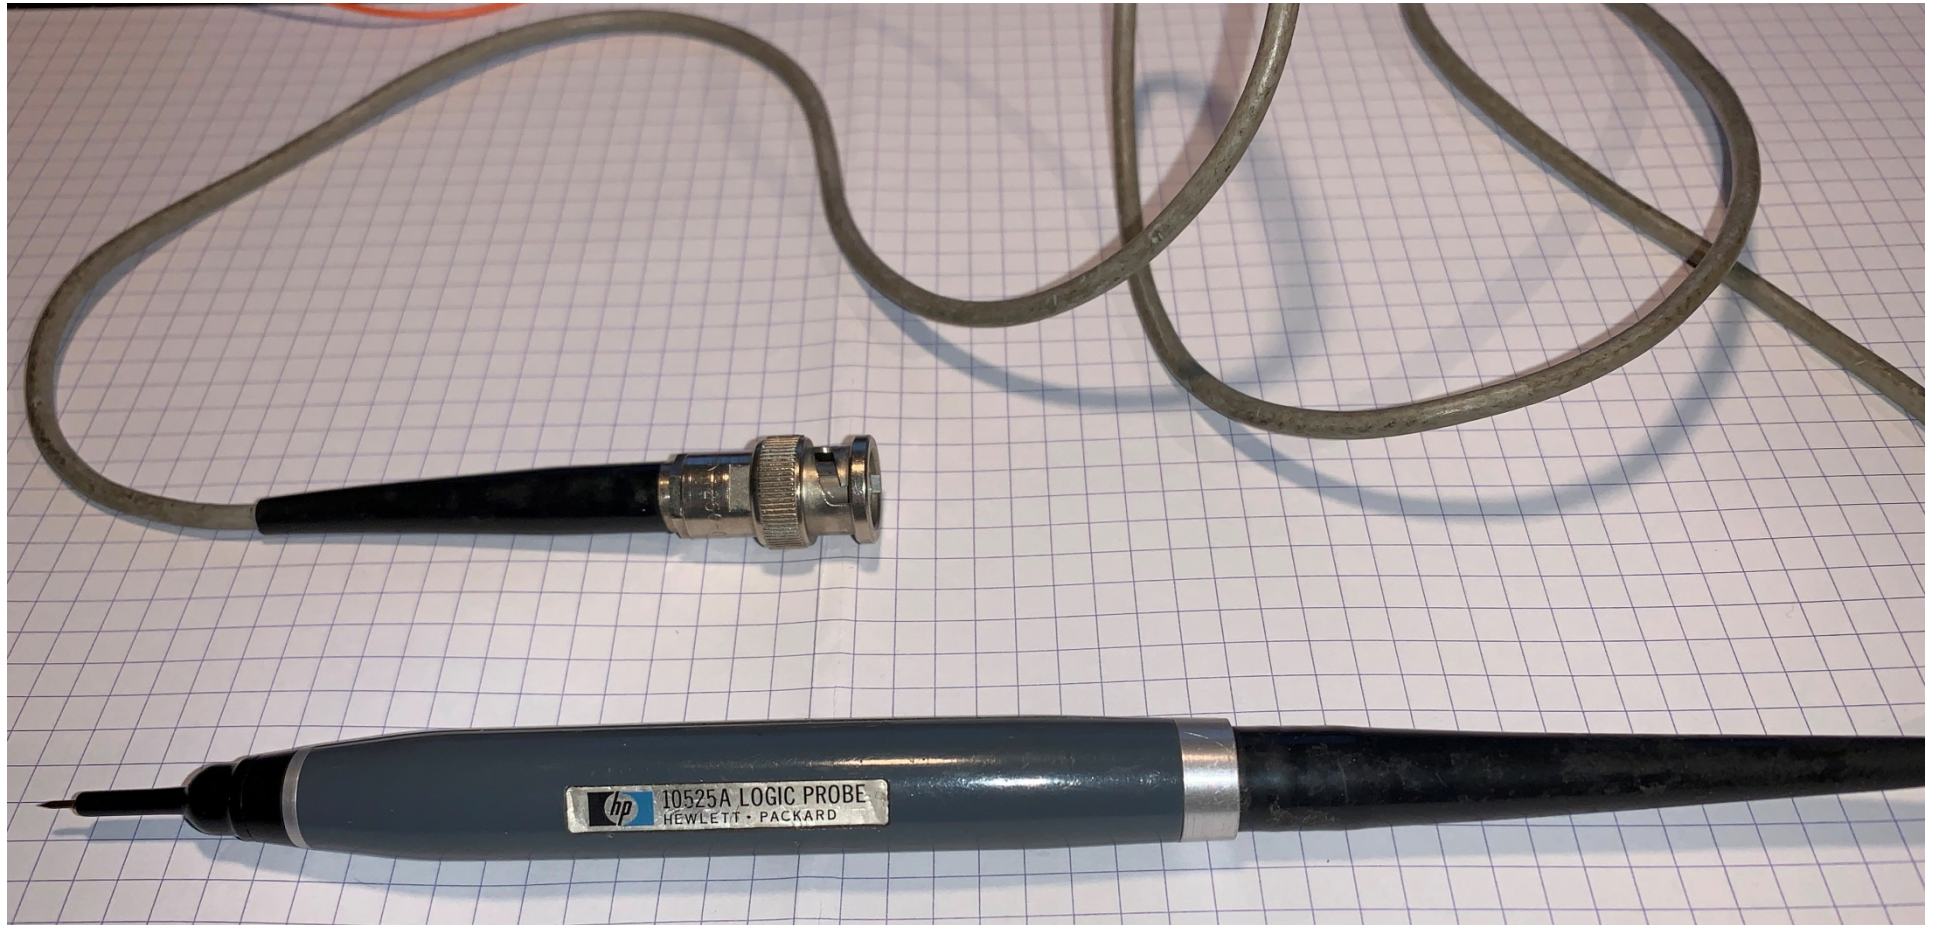
Figure 1 – The HP10525A logic probe

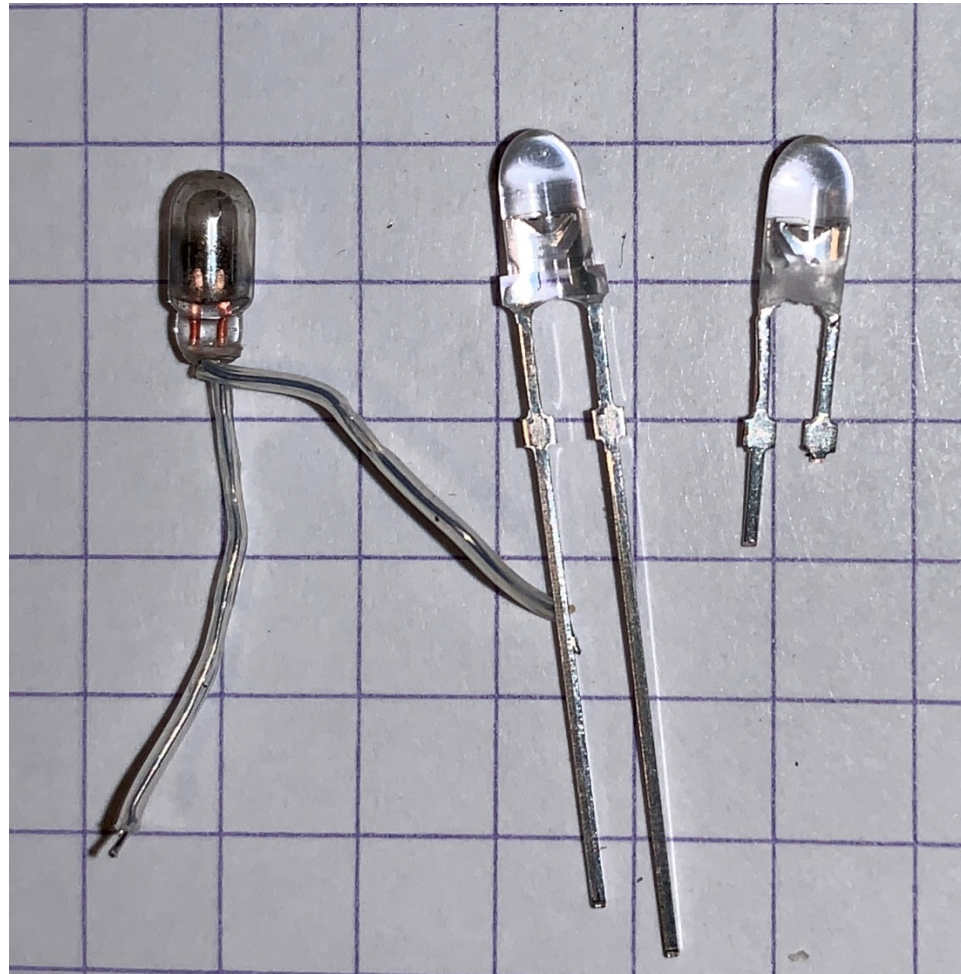
Figure 5 – Comparing the bulb, an untouched LED and a cropped and filed down LED
